**Lettre datée du 27 juin 2019, adressée au Secrétaire général  
par le Chargé d'affaires par intérim de la Mission permanente  
des États-Unis d'Amérique auprès de l'Organisation  
des Nations Unies**

**Annexe I à la lettre datée du 27 juin 2019 adressée au Secrétaire  
général par le Chargé d'affaires par intérim de la Mission  
permanente des États-Unis d'Amérique auprès de l'Organisation  
des Nations Unies**

UNCLASSIFIED U.S.  
ASSESSMENT OF RECENT INCIDENTS  
IN THE PERSIAN GULF

## M/V KOKUKA COURAGEOUS Attacked With Iranian Indigenous Extra-Large Limpet Mines (High Confidence)

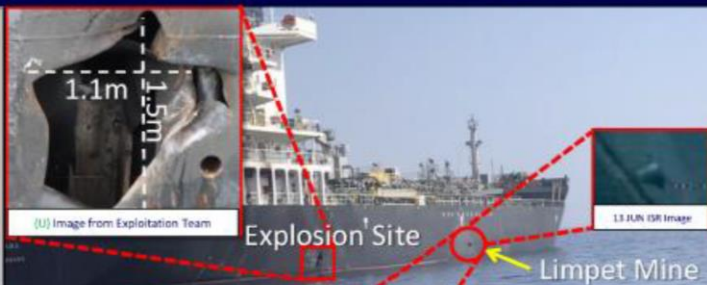
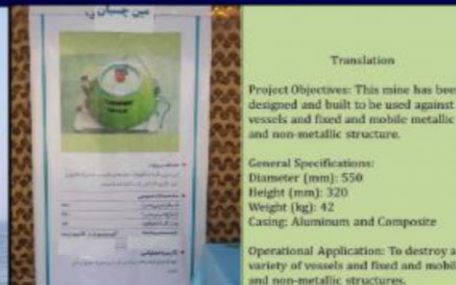
- (U) Imagery observed object on starboard side of the vessel (witnessed being removed by Iranian Naval forces) consistent with limpet mine size and shape
- (U) Recovered magnet and explosive cartridge actuated nail holes consistent with limpet mine attachment techniques
- (U) Imprint is consistent with an Iranian "Indigenous Extra-Large" limpet mine
- (U) 2x nail holes at the imprint site are consistent with an Iranian "Indigenous Extra-Large" limpet mine
- (U) Aluminum and composite remnants on the recovered magnet are consistent with advertised Iranian "Indigenous Extra-Large" limpet mine material composition
- (U) Mine appears consistent with Iranian-made limpet mines displayed publicly by Iran

(U) Brochure for Iranian Indigenous Extra-Large Limpet Mine, Publicly Revealed at 2015 Military Display

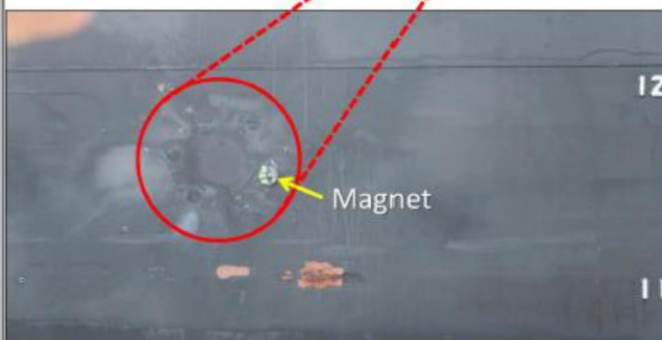
(U) 14 JUN image of M/V KOKUKA COURAGEOUS

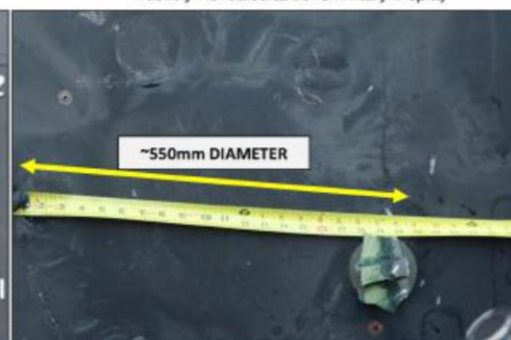
(U) Measurements are consistent with advertised Iranian Indigenous Extra-Large Limpet Mine diameter

(U) NAVCENT and the Office of Naval Intelligence assesses with high confidence the limpet mines used in the attack on the M/V KOKUKA COURAGEOUS were of Iranian origin and design, based on exploitation and our understanding of the technical characteristics of world-wide limpet mines. Furthermore, the attack was almost certainly conducted by the Islamic Revolutionary Guard Corps Navy (IRGCN), based on historical Iranian press video of IRGCN training with the same class of limpet mine and an IRGCN vessel being used to retrieve the unexploded mine after the attacks.

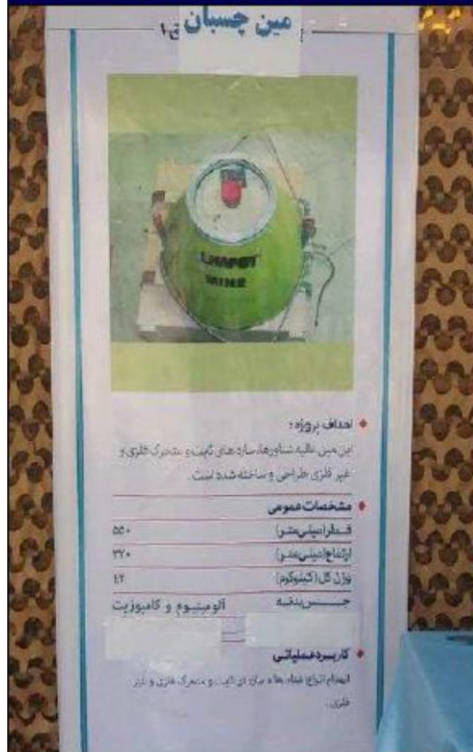
(U) Brochure for Iranian Indigenous Extra-Large Limpet Mine, Publicly Revealed at 2015 Military Display

**Project Objectives:** This mine has been designed and built to be used against vessels and fixed and mobile metallic and non-metallic structure.

**Diameter (mm): 550**

**Height (mm): 320**

**Weight (kg): 42**

**Casing: Aluminum and Composite**

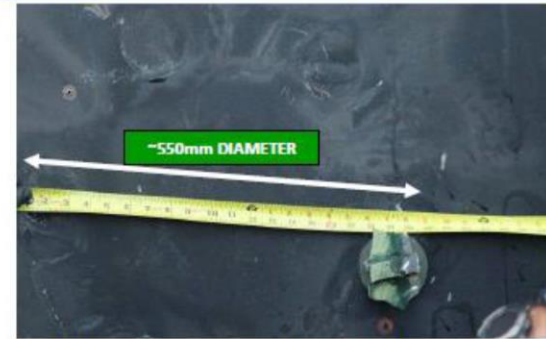
(U) Measurements are consistent with reported diameter of Iranian Extra-Large limpet mine

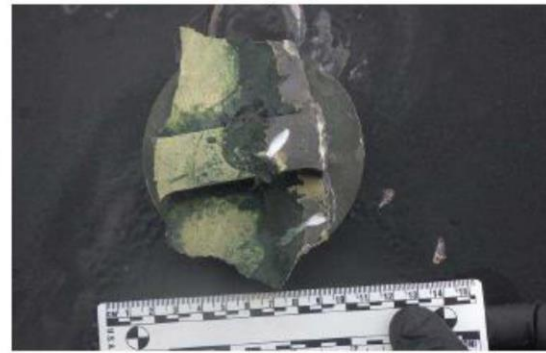
(U) Magnet 3.5" diameter; aluminum, composite remnants

(U) The green composite material on the recovered magnet, location of the cartridge-actuated nail holes, number of nail holes, and diameter of the limpet placement area is consistent with the Iranian "Indigenous Extra-Large" limpet mine advertised in a 2015 arms display. Chemical analysis of collected explosive residue swabs is pending.

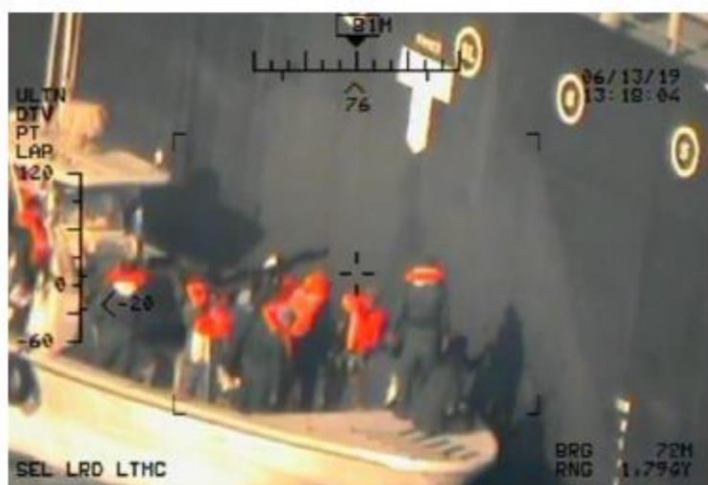
Imagery taken from a U.S. Navy MH-60R helicopter of the Islamic Revolutionary Guard Corps Navy removing an unexploded limpet mine from the M/T Kokuka Courageous.

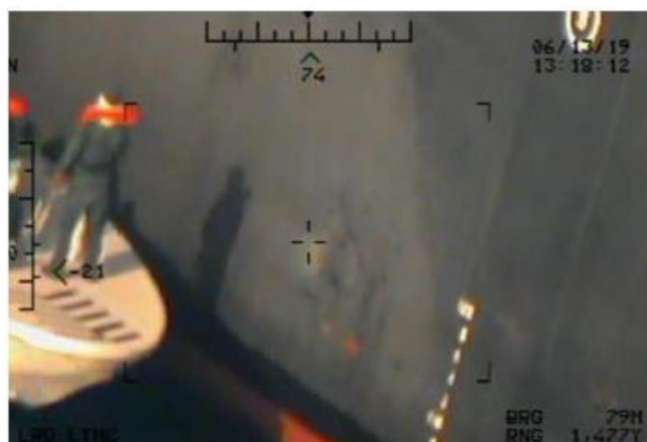
Imagery taken from a U.S. Navy MH-60R helicopter of the Islamic Revolutionary Guard Corps Navy after removing an unexploded limpet mine from the M/T Kokuka Courageous.

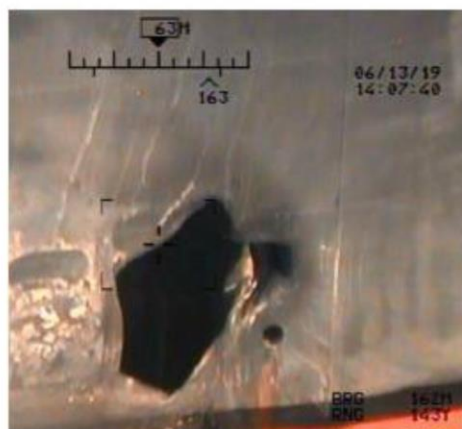
The Motor Tanker (M/T) Kokuka Courageous sustained damage from a limpet mine attack while operating in the Gulf of Oman, on June 13th. Limpet mines are attached to a vessel via magnets and/or nails and detonated by a timer. Following the attack, sailors from the Kokuka Courageous discovered a second, unexploded, limpet mine on their vessel and abandoned ship. The Dutch tug Coastal Ace rescued the crew of 21 sailors. The USS Bainbridge (DDG 96) then transferred and transported the Sailors to safety. Later that day, an Islamic Revolutionary Guard Corps (IRGC) Gashti Class patrol boat approached Kokuka Courageous and was observed and recorded by a U.S. Navy MH-60R helicopter removing the unexploded limpet mine from Kokuka Courageous. Iran is responsible for the attack based on video evidence and the resources and proficiency needed to quickly remove the unexploded limpet mine. The hull penetration measures 1.1m at the widest point by 1.5m 4'2" x 3'8" (H x W) at the tallest point. The penetration begins approximately 1m above the water line.

Imagery taken from a U.S. Navy MH-60R helicopter of blast damage to M/T Kokuka Courageous. M/V Kokuka Courageous received damage consistent with a limpet mine attack in the Gulf of Oman, June 13.

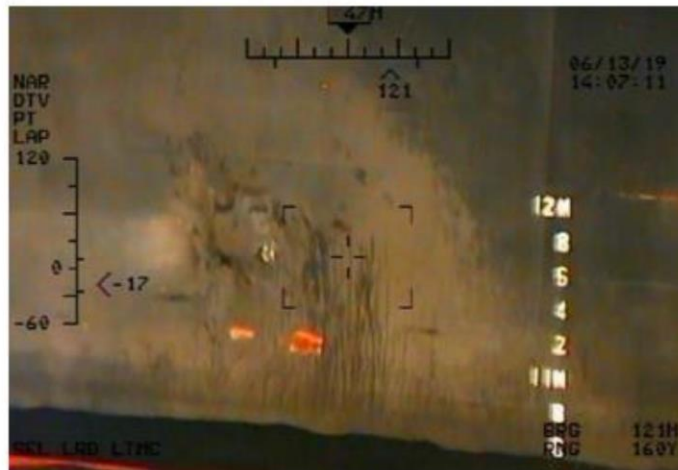
Imagery taken from a U.S. Navy MH-60R helicopter of the Islamic Revolutionary Guard Corps Navy of the remnants of the magnetic attachment device of unexploded limpet mine from the M/T Kokuka Courageous.

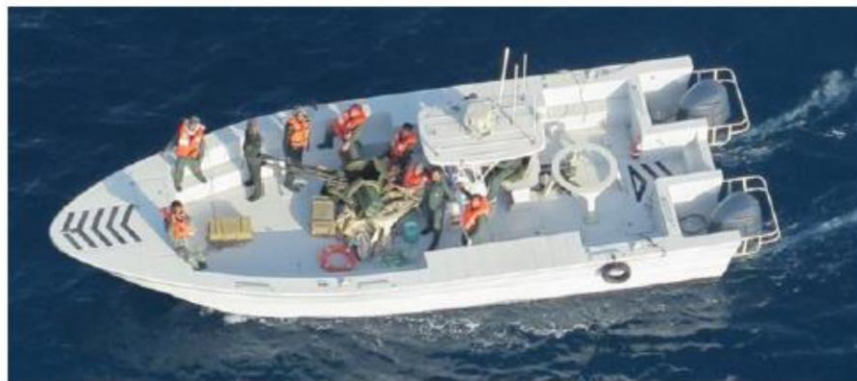
Imagery taken from a U.S. Navy MH-60R helicopter of the Islamic Revolutionary Guard Corps Navy after removing an unexploded limpet mine from the M/T Kokuka Courageous.

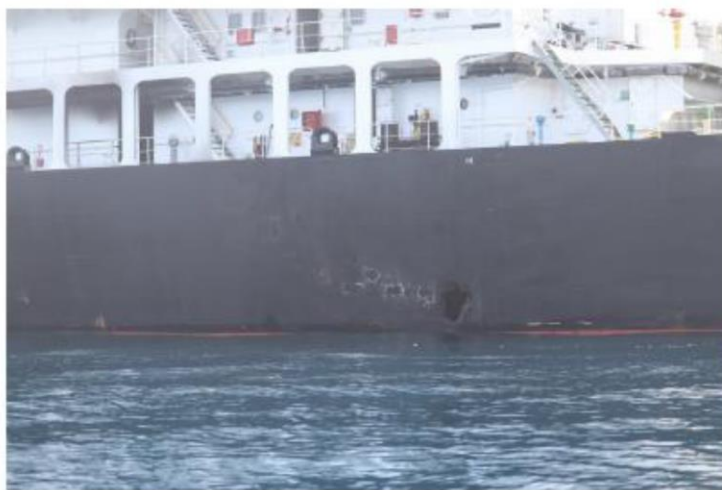
7710 - This is a view of hull penetration/blast damage on the starboard side of motor vessel M/T Kokuka Courageous, which was sustained from a limpet mine attack while operating in the Gulf of Oman, on June 13th.

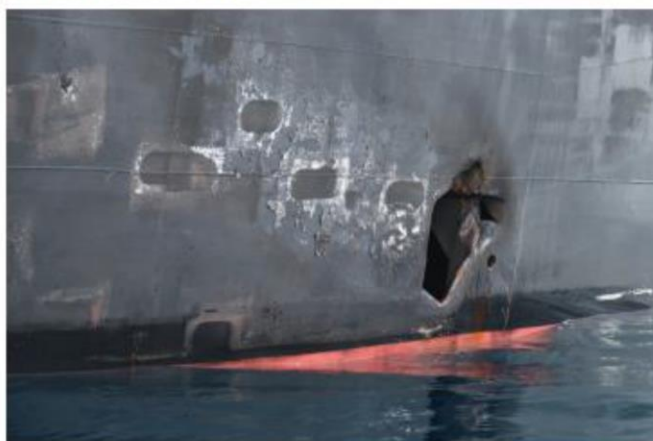
7725 - This photo is a view of hull penetration/blast damage sustained from a limpet mine attack on the starboard side of motor vessel M/T Kokuka Courageous, while operating in the Gulf of Oman, June 13.

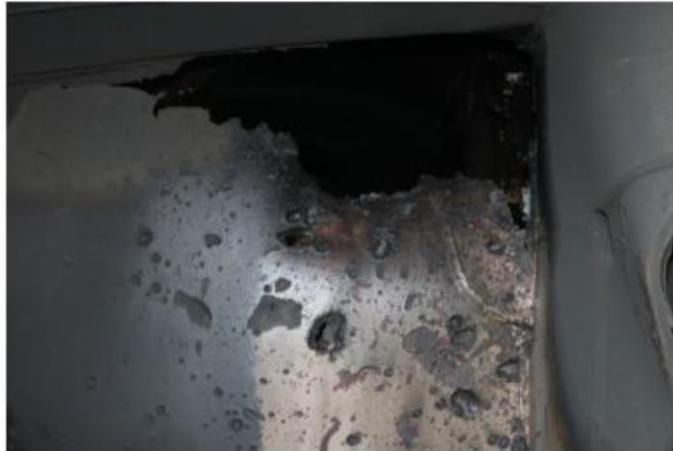
7729 - This photo is a view of internal hull penetration/blast damage sustained from a limpet mine attack on the starboard side of motor vessel M/T Kokuka Courageous, while operating in the Gulf of Oman, June 13.

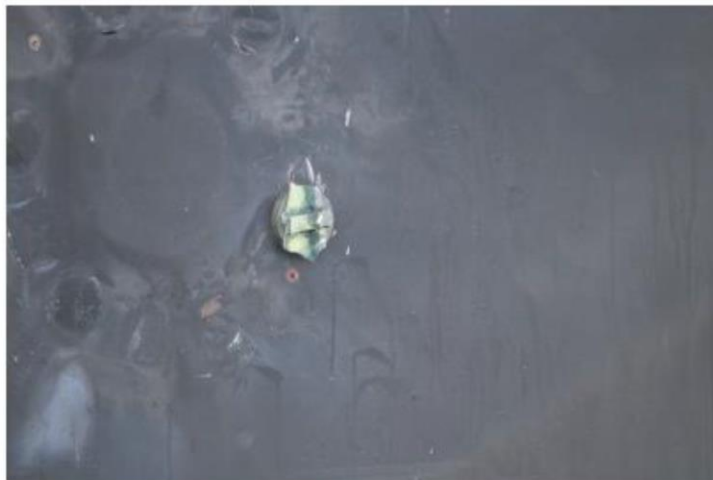
7714 - This is the view of the remnants of a removed limpet mine's placement, location, and damage sustained from a limpet mine attack, on the starboard side of motor vessel M/T Kokuka Courageous, while operating in the Gulf of Oman, June 13. A limpet mine is attached to a vessel via magnet and/or nails. The holes seen were created by nails used to hold the mine in place.

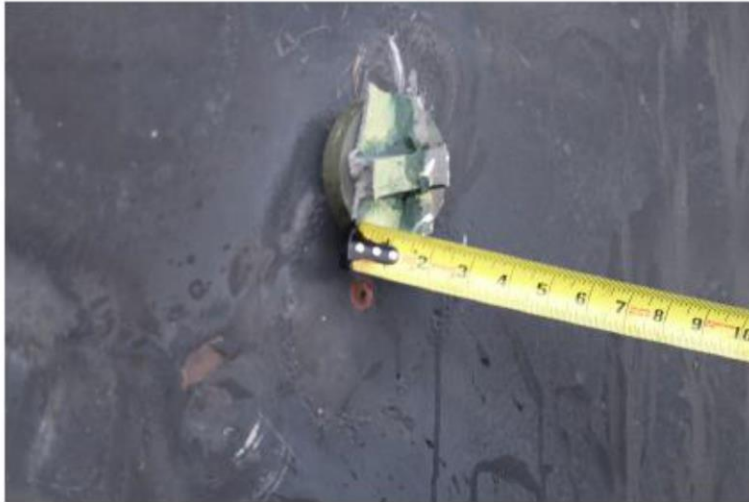
7761 -This photo depicts the aluminum and green composite material left behind following removal of an unexploded limpet mine used in an attack on the starboard side of motor vessel M/T Kokuka Courageous, while operating in the Gulf of Oman, June 13th.
