## 2019年6月27日美利坚合众国常驻联合国代表团临时代办给秘书长的信

UNCLASSIFIED U.S.  
ASSESSMENT OF RECENT INCIDENTS  
IN THE PERSIAN GULF

### M/V KOKUKA COURAGEOUS Attacked With Iranian Indigenous Extra-Large Limpet Mines (High Confidence)

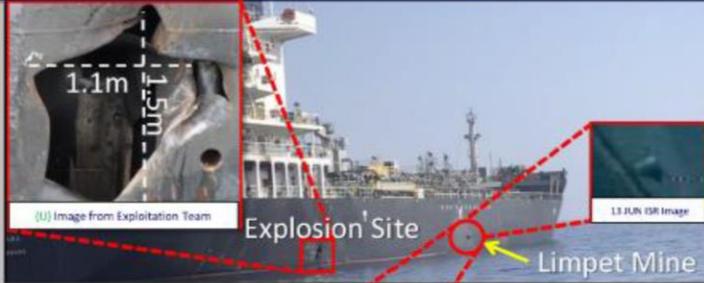
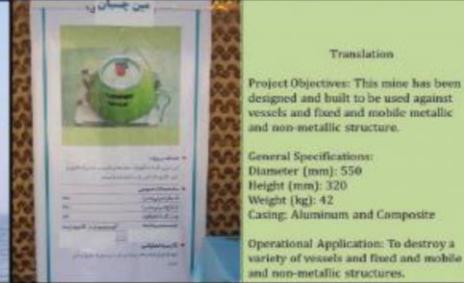
(U) Brochure for Iranian Indigenous Extra-Large Limpet Mine, Publicly Revealed at 2015 Military Display

- The type of limpet mine observed in this incident is unique in structure when compared to the international inventory of limpet mines. It bears a striking resemblance to and is consistent with Iranian made limpet mines that have been publicly displayed by Iran. The green composite material on the recovered magnet, location of the cartridge-actuated nail holes, number of nail holes, and diameter of the limpet placement area is consistent with the Iranian "Indigenous Extra-Large" limpet mine advertised in a 2015 arms display.

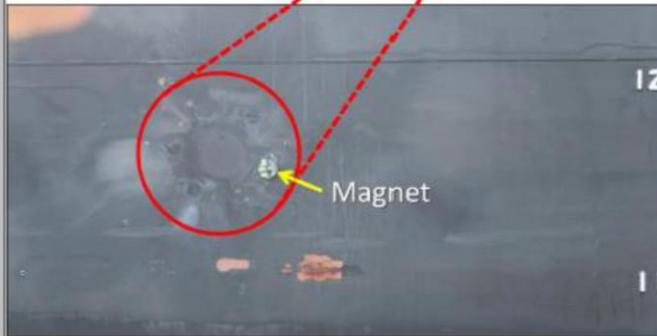
- (U) Imagery observed object on starboard side of the vessel (witnessed being removed by Iranian Naval forces) consistent with limpet mine size and shape
- (U) Recovered magnet and explosive cartridge actuated nail holes consistent with limpet mine attachment techniques
- (U) Imprint is consistent with an Iranian "Indigenous Extra-Large" limpet mine
- (U) 2x nail holes at the imprint site are consistent with an Iranian "Indigenous Extra-Large" limpet mine
- (U) Aluminum and composite remnants on the recovered magnet are consistent with advertised Iranian "Indigenous Extra-Large" limpet mine material composition
- (U) Mine appears consistent with Iranian-made limpet mines displayed publicly by Iran

(U) 14 JUN image of M/V KOKUKA COURAGEOUS

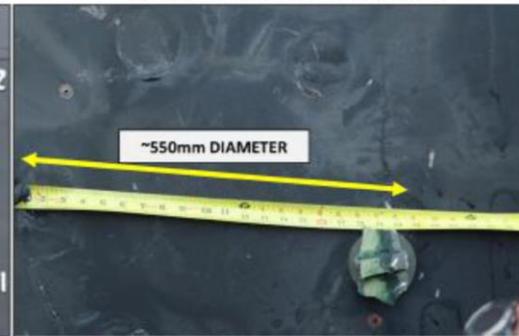
(U) Measurements are consistent with advertised Iranian Indigenous Extra-Large Limpet Mine diameter

(U) NAVCENT and the Office of Naval Intelligence assesses with high confidence the limpet mines used in the attack on the M/V KOKUKA COURAGEOUS were of Iranian origin and design, based on exploitation and our understanding of the technical characteristics of world-wide limpet mines. Furthermore, the attack was almost certainly conducted by the Islamic Revolutionary Guard Corps Navy (IRGCN), based on historical Iranian press video of IRGCN training with the same class of limpet mine and an IRGCN vessel being used to retrieve the unexploded mine after the attacks.

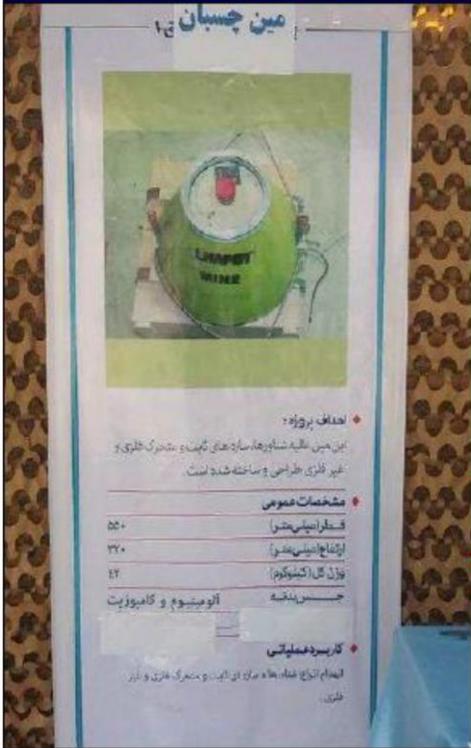
(U) Brochure for Iranian Indigenous Extra-Large Limpet Mine, Publicly Revealed at 2015 Military Display

**Project Objectives:** This mine has been designed and built to be used against vessels and fixed and mobile metallic and non-metallic structure.

- General Specifications:**
- Diameter (mm): 550
  - Height (mm): 320
  - Weight (kg): 42
  - Casing: Aluminum and Composite

**Operational Application:** To destroy a variety of vessels and fixed and mobile and non-metallic structures.

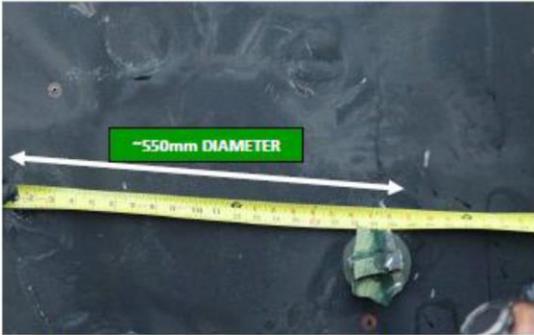
(U) Measurements are consistent with reported diameter of Iranian Extra-Large limpet mine

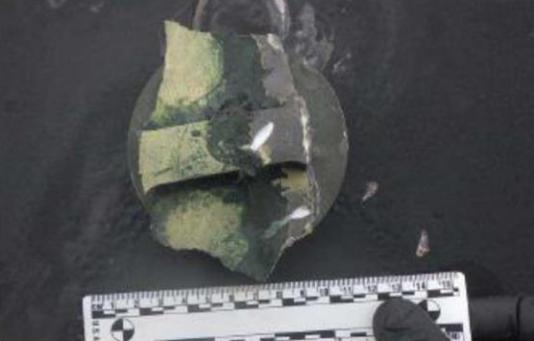
(U) Magnet 3.5" diameter; aluminum, composite remnants

(U) The green composite material on the recovered magnet, location of the cartridge-actuated nail holes, number of nail holes, and diameter of the limpet placement area is consistent with the Iranian "Indigenous Extra-Large" limpet mine advertised in a 2015 arms display. Chemical analysis of collected explosive residue swabs is pending.

- A U.S. Navy Explosive Ordnance Disposal team has gathered fragments and pieces of metal from the external explosion onboard the Kokuka Courageous as well as explosive residue, fingerprints, and trace evidence to process through explosive and biometric laboratories. We will continue to assess this evidence.

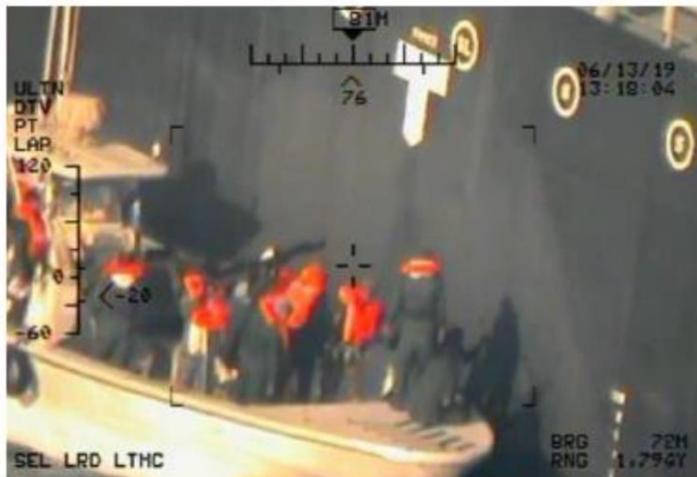
Imagery taken from a U.S. Navy MH-60R helicopter of the Islamic Revolutionary Guard Corps Navy removing an unexploded limpet mine from the M/T Kokuka Courageous.

- We also have post-attack video of an Iranian military vessel pulling up at high speed alongside the Kokuka Courageous to remove an object from the hull. We assess this object to be an unexploded limpet mine. The procedures the IRGC personnel followed were inconsistent with standard safety practices that Explosive Ordnance Disposal teams would employ when approaching unknown ordnance. The video, which has been released publicly, shows that IRGC personnel took no safety precautions when approaching or removing the ordnance, suggesting they knew how it was intended to function and exactly where it was. The removal and

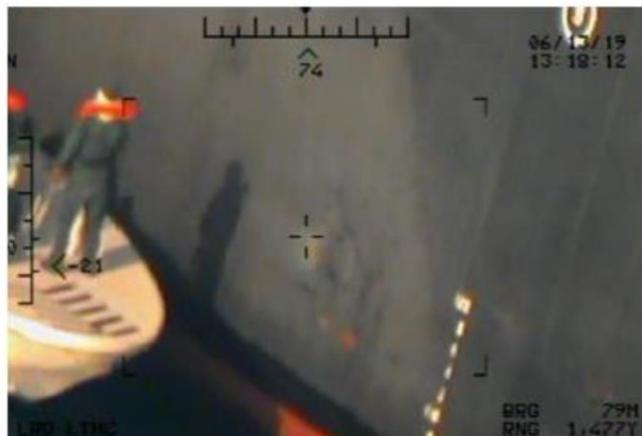
Imagery taken from a U.S. Navy MH-60R helicopter of the Islamic Revolutionary Guard Corps Navy after removing an unexploded limpet mine from the M/T Kokuka Courageous.

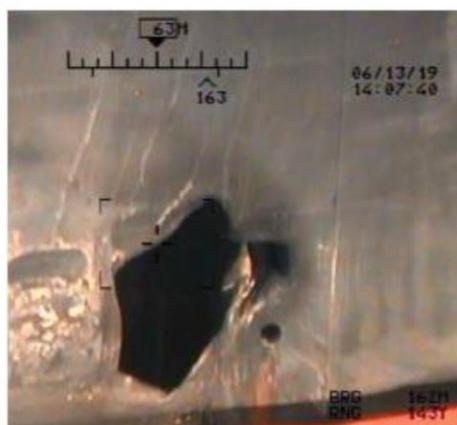
The Motor Tanker (M/T) Kokuka Courageous sustained damage from a limpet mine attack while operating in the Gulf of Oman, on June 13th. Limpet mines are attached to a vessel via magnets and/or nails and detonated by a timer. Following the attack, sailors from the Kokuka Couragous discovered a second, unexploded, limpet mine on their vessel and abandoned ship. The Dutch tug Coastal Ace rescued the crew of 21 sailors. The USS Bainbridge (DDG 96) then transferred and transported the Sailors to safety. Later that day, an Islamic Revolutionary Guard Corps (IRGC) Gashti Class patrol boat approached Kokuka Courageous and was observed and recorded by a U.S. Navy MH-60R helicopter removing the unexploded limpet mine from Kokuka Courageous. Iran is responsible for the attack based on video evidence and the resources and proficiency needed to quickly remove the unexploded limpet mine. The hull penetration measures 1.1m at the widest point by 1.5m 4'2" x 3'8" (H x W) at the tallest point. The penetration begins approximately 1m above the water line.

Imagery taken from a U.S. Navy MH-60R helicopter of blast damage to M/T Kokuka Courageous. M/V Kokuka Courageous received damage consistent with a limpet mine attack in the Gulf of Oman, June 13.

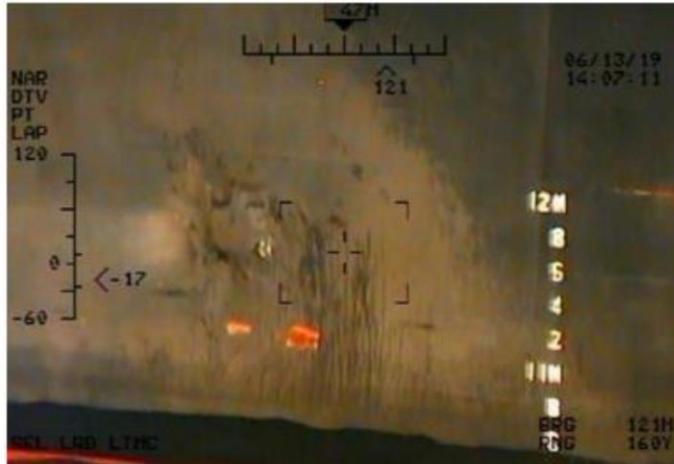
Imagery taken from a U.S. Navy MH-60R helicopter of the Islamic Revolutionary Guard Corps Navy of the remnants of the magnetic attachment device of unexploded limpet mine from the M/T Kokuka Courageous.

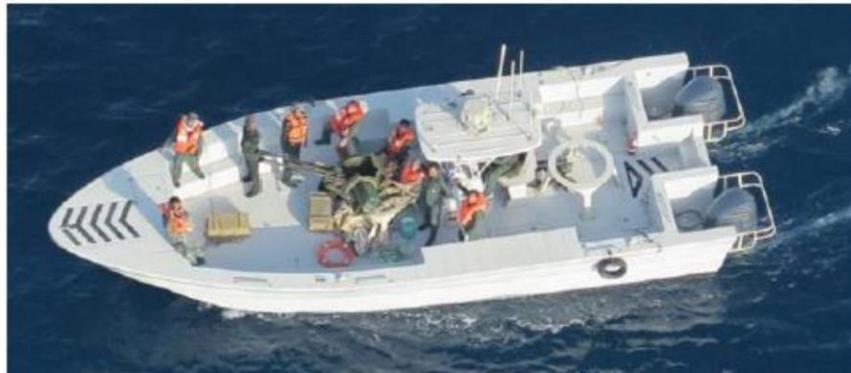
Imagery taken from a U.S. Navy MH-60R helicopter of the Islamic Revolutionary Guard Corps Navy after removing an unexploded limpet mine from the M/T Kokuka Courageous.

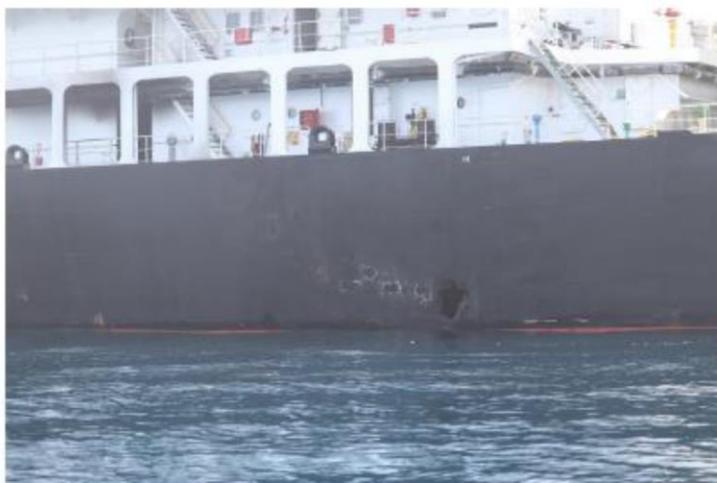
7710 - This is a view of hull penetration/blast damage on the starboard side of motor vessel M/T Kokuka Courageous, which was sustained from a limpet mine attack while operating in the Gulf of Oman, on June 13th.

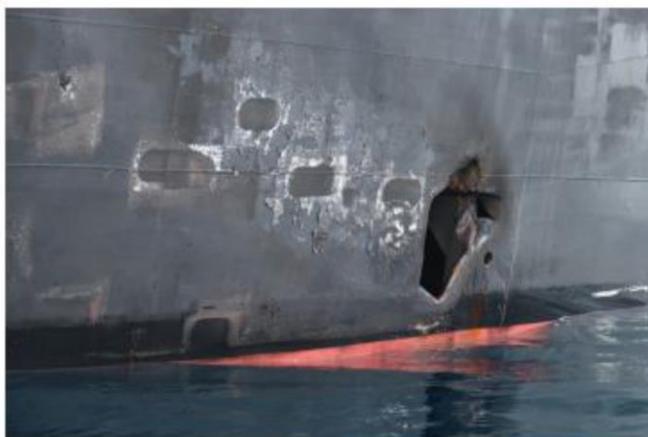
7725 - This photo is a view of hull penetration/blast damage sustained from a limpet mine attack on the starboard side of motor vessel M/T Kokuka Courageous, while operating in the Gulf of Oman, June 13.

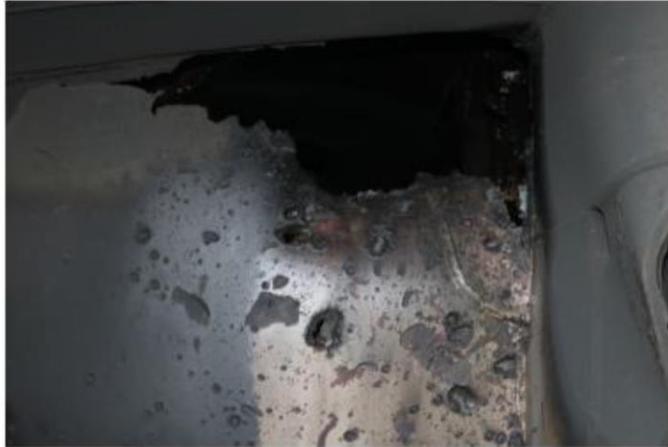
7729 - This photo is a view of internal hull penetration/blast damage sustained from a limpet mine attack on the starboard side of motor vessel M/T Kokuka Courageous, while operating in the Gulf of Oman, June 13.

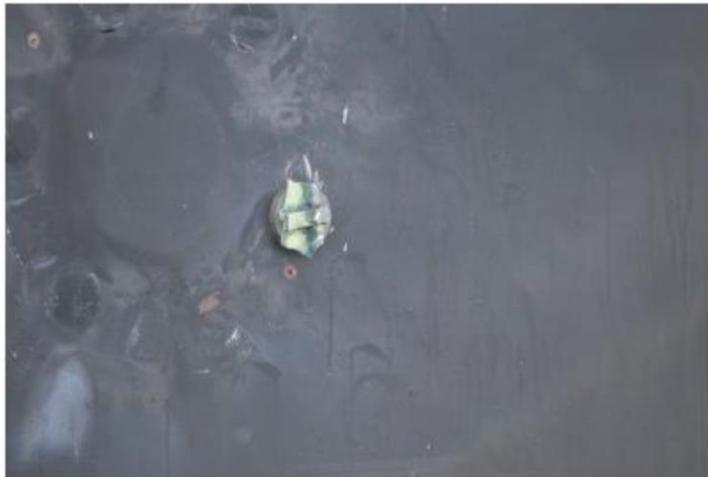
7714 - This is the view of the remnants of a removed limpet mine's placement, location, and damage sustained from a limpet mine attack, on the starboard side of motor vessel M/T Kokuka Courageous, while operating in the Gulf of Oman, June 13. A limpet mine is attached to a vessel via magnet and/or nails. The holes seen were created by nails used to hold the mine in place.

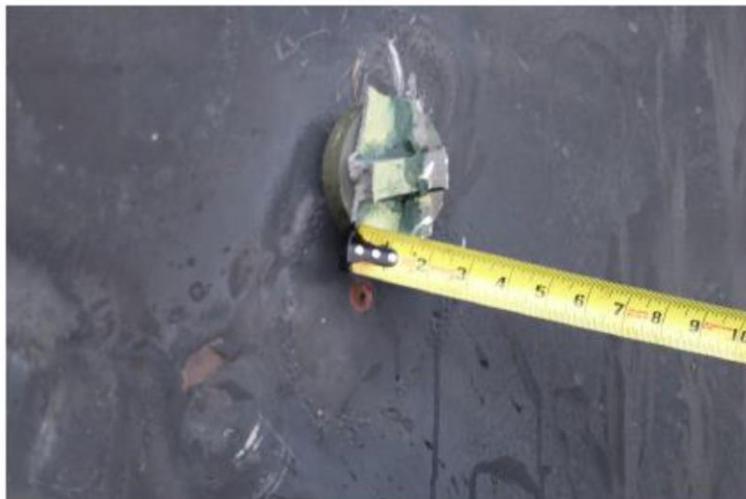
7761 -This photo depicts the aluminum and green composite material left behind following removal of an unexploded limpet mine used in an attack on the starboard side of motor vessel M/T Kokuka Courageous, while operating in the Gulf of Oman, June 13th.
