UNCLASSIFIED U.S.
ASSESSMENT OF RECENT INCIDENTS
IN THE PERSIAN GULF

M/V KOKUKA COURAGEOUS Attacked With Iranian Indigenous Extra-Large Limpet Mines (High Confidence)

Statement explaining additional imagery:

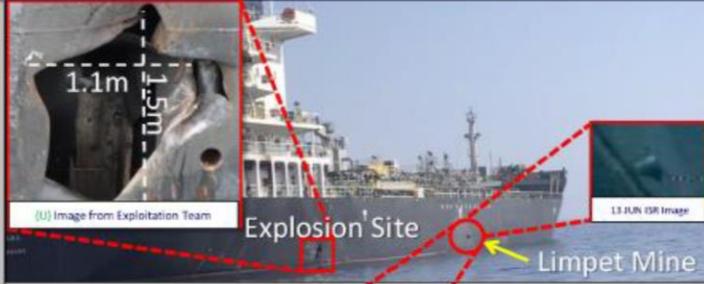
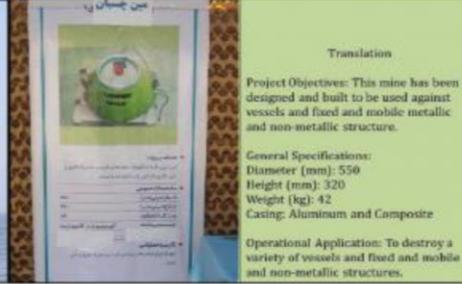
- (U) Imagery observed object on starboard side of the vessel (witnessed being removed by Iranian Naval forces) consistent with limpet mine size and shape
- (U) Recovered magnet and explosive cartridge actuated nail holes consistent with limpet mine attachment techniques
- (U) Imprint is consistent with an Iranian "Indigenous Extra-Large" limpet mine
- (U) 2x nail holes at the imprint site are consistent with an Iranian "Indigenous Extra-Large" limpet mine
- (U) Aluminum and composite remnants on the recovered magnet are consistent with advertised Iranian "Indigenous Extra-Large" limpet mine material composition
- (U) Mine appears consistent with Iranian-made limpet mines displayed publicly by Iran

(U) Brochure for Iranian Indigenous Extra-Large Limpet Mine, Publicly Revealed at 2015 Military Display

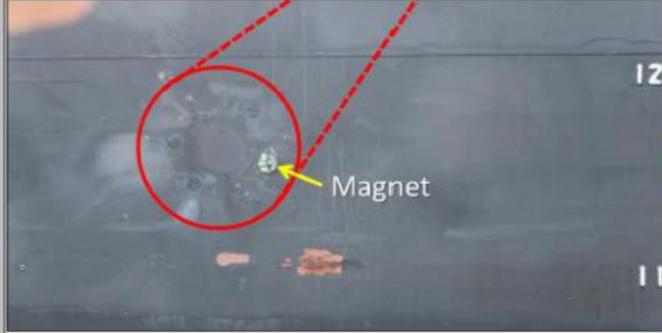
(U) 14 JUN image of M/V KOKUKA COURAGEOUS

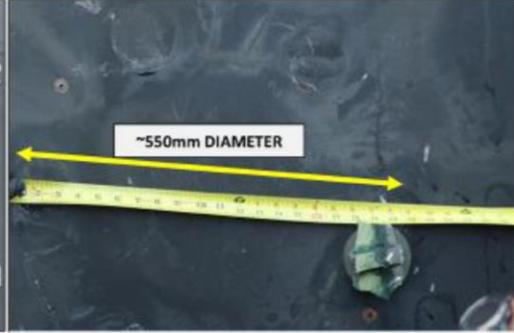
(U) Measurements are consistent with advertised Iranian Indigenous Extra-Large Limpet Mine diameter

(U) NAVCENT and the Office of Naval Intelligence assesses with high confidence the limpet mines used in the attack on the M/V KOKUKA COURAGEOUS were of Iranian origin and design, based on exploitation and our understanding of the technical characteristics of world-wide limpet mines. Furthermore, the attack was almost certainly conducted by the Islamic Revolutionary Guard Corps Navy (IRGCN), based on historical Iranian press video of IRGCN training with the same class of limpet mine and an IRGCN vessel being used to retrieve the unexploded mine after the attacks.

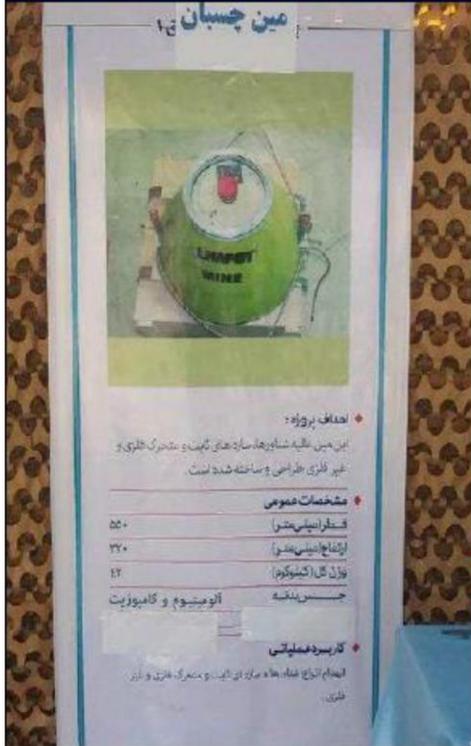
(U) Brochure for Iranian Indigenous Extra-Large Limpet Mine, Publicly Revealed at 2015 Military Display

Project Objectives: This mine has been designed and built to be used against vessels and fixed and mobile metallic and non-metallic structure.

Diameter (mm): 550

Height (mm): 320

Weight (kg): 42

Casing: Aluminum and Composite

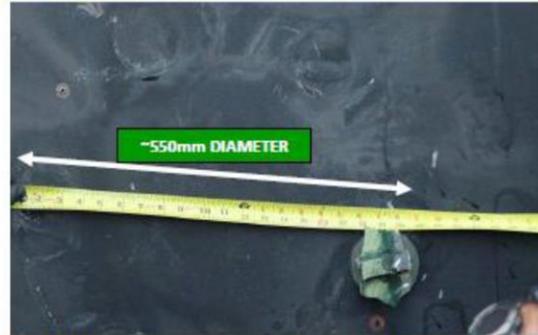
(U) Measurements are consistent with reported diameter of Iranian Extra-Large limpet mine

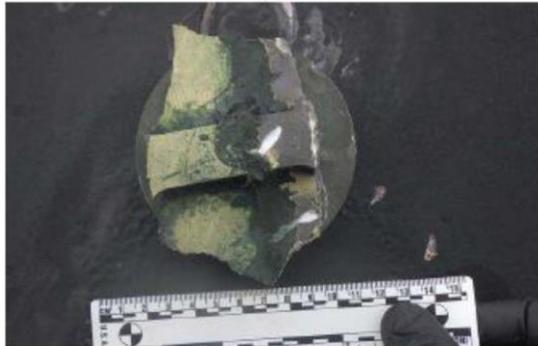
(U) Magnet 3.5" diameter; aluminum, composite remnants

(U) The green composite material on the recovered magnet, location of the cartridge-actuated nail holes, number of nail holes, and diameter of the limpet placement area is consistent with the Iranian "Indigenous Extra-Large" limpet mine advertised in a 2015 arms display. Chemical analysis of collected explosive residue swabs is pending.

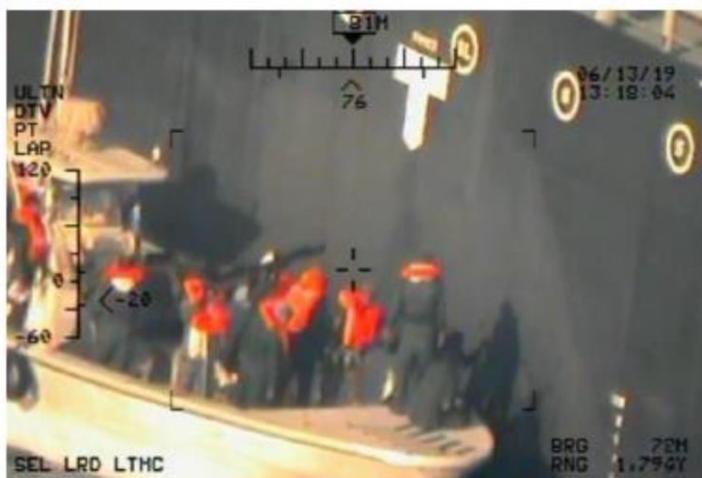
Imagery taken from a U.S. Navy MH-60R helicopter of the Islamic Revolutionary Guard Corps Navy removing an unexploded limpet mine from the M/T Kokuka Courageous.

The Motor Tanker (M/T) Kokuka Courageous sustained damage from a limpet mine attack while operating in the Gulf of Oman, on June 13th. Limpet mines are attached to a vessel via magnets and/or nails and detonated by a timer. Following the attack, sailors from the Kokuka Couragous discovered a second, unexploded, limpet mine on their vessel and abandoned ship. The Dutch tug Coastal Ace rescued the crew of 21 sailors. The USS Bainbridge (DDG 96) then transferred and transported the Sailors to safety. Later that day, an Islamic Revolutionary Guard Corps (IRGC) Gashti Class patrol boat approached Kokuka Courageous and was observed and recorded by a U.S. Navy MH-60R helicopter removing the unexploded limpet mine from Kokuka Courageous. Iran is responsible for the attack based on video evidence and the resources and proficiency needed to quickly remove the unexploded limpet mine. The hull penetration measures 1.1m at the widest point by 1.5m 4'2" x 3'8" (H x W) at the tallest point. The penetration begins approximately 1m above the water line.

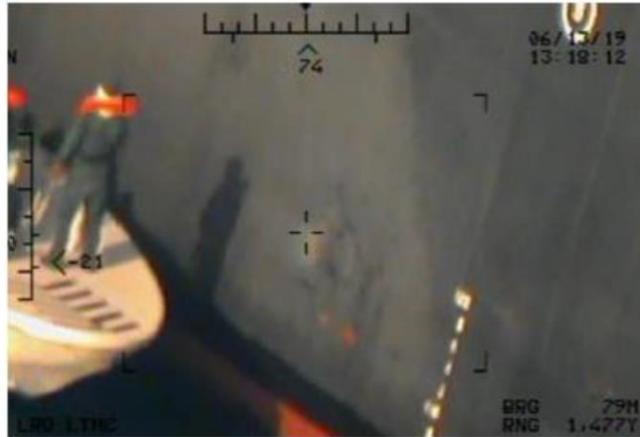
Imagery taken from a U.S. Navy MH-60R helicopter of the Islamic Revolutionary Guard Corps Navy after removing an unexploded limpet mine from the M/T Kokuka Courageous.

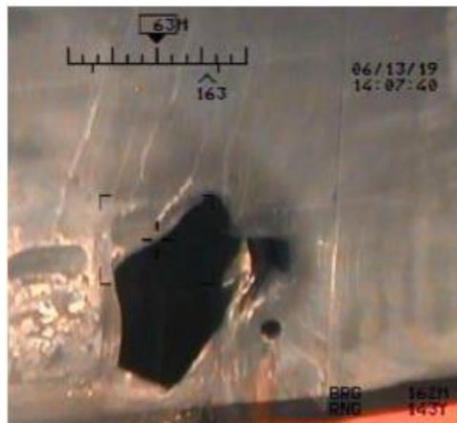
Imagery taken from a U.S. Navy MH-60R helicopter of blast-damage to M/T Kokuka Courageous. M/V Kokuka Courageous received damage consistent with a limpet mine attack in the Gulf of Oman, June 13.

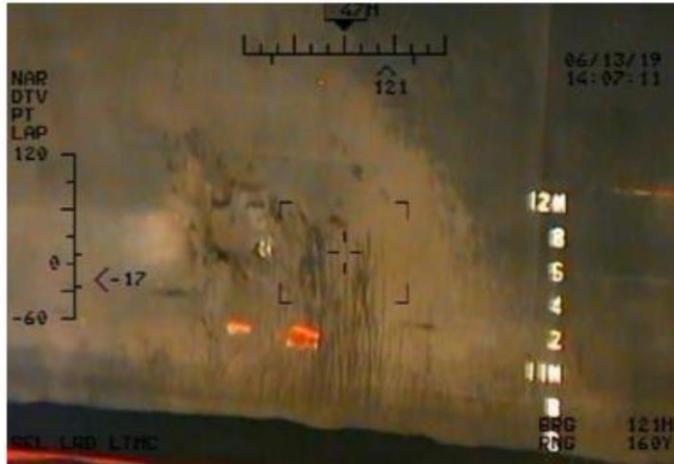
Imagery taken from a U.S. Navy MH-60R helicopter of the Islamic Revolutionary Guard Corps Navy of the remnants of the magnetic attachment device of unexploded limpet mine from the M/T Kokuka Courageous.

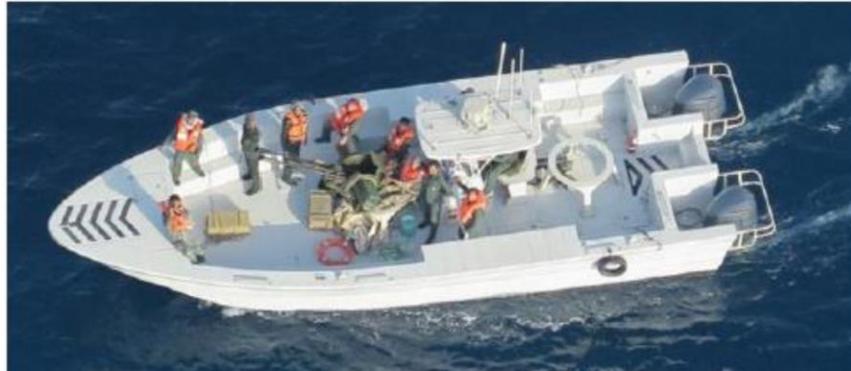
Imagery taken from a U.S. Navy MH-60R helicopter of the Islamic Revolutionary Guard Corps Navy after removing an unexploded limpet mine from the M/T Kokuka Courageous.

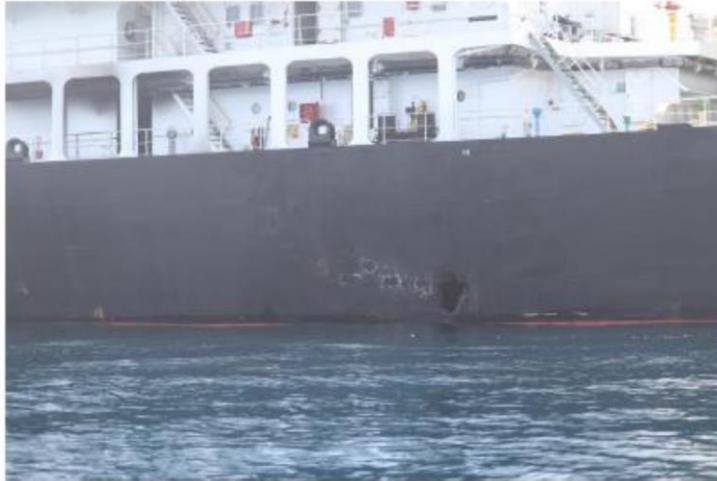
7710 - This is a view of hull penetration/blast damage on the starboard side of motor vessel M/T Kokuka Courageous, which was sustained from a limpet mine attack while operating in the Gulf of Oman, on June 13th.

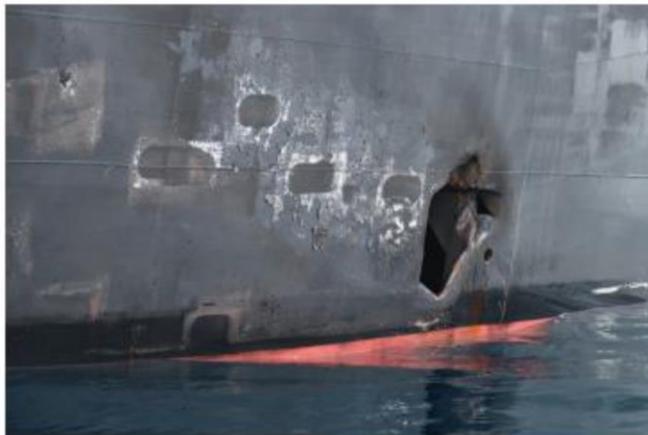
7725 - This photo is a view of hull penetration/blast damage sustained from a limpet mine attack on the starboard side of motor vessel M/T Kokuka Courageous, while operating in the Gulf of Oman, June 13.

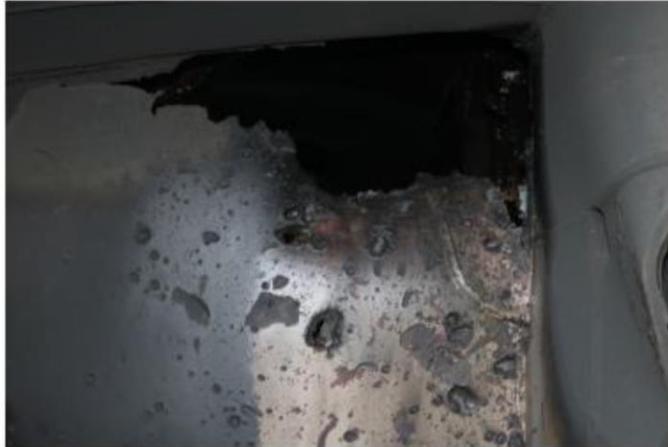
7729 - This photo is a view of internal hull penetration/blast damage sustained from a limpet mine attack on the starboard side of motor vessel M/T Kokuka Courageous, while operating in the Gulf of Oman, June 13.

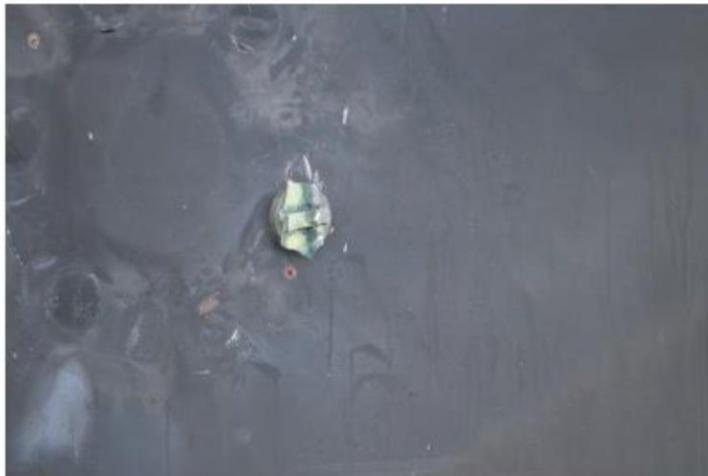
7714 - This is the view of the remnants of a removed limpet mine's placement, location, and damage sustained from a limpet mine attack, on the starboard side of motor vessel M/T Kokuka Courageous, while operating in the Gulf of Oman, June 13. A limpet mine is attached to a vessel via magnet and/or nails. The holes seen were created by nails used to hold the mine in place.

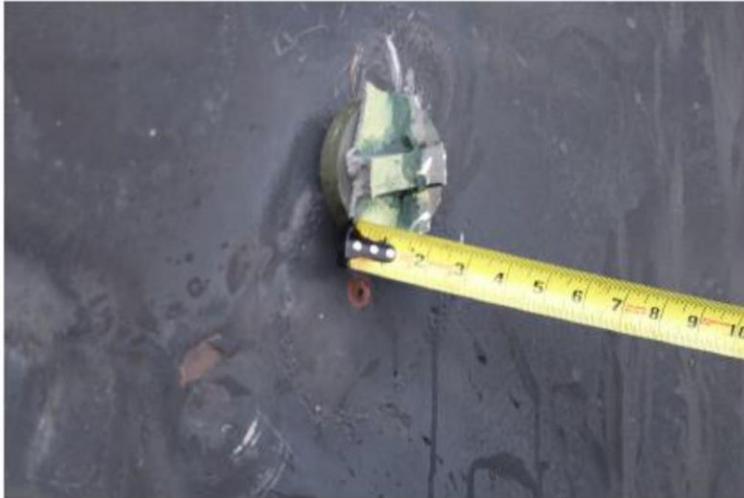
7761 -This photo depicts the aluminum and green composite material left behind following removal of an unexploded limpet mine used in an attack on the starboard side of motor vessel M/T Kokuka Courageous, while operating in the Gulf of Oman, June 13th.
