### Letter dated 17 June 2019 from the Permanent Representatives of Norway, Saudi Arabia and the United Arab Emirates to the United Nations addressed to the President of the Security Council

**Initial report on the oil tanker attacks off the port of Fujairah, United Arab Emirates, on 12 May 2019**

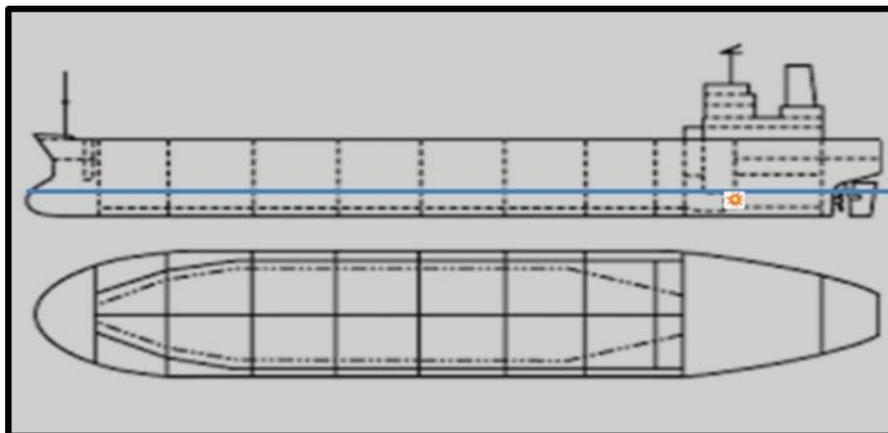
Investigation of the damage sustained by the AMJAD indicates that the seat of the explosion was located on the port side, approximately 3.30 metres below the waterline level, at the engine chamber. As with the other three explosions, this explosion caused the perforation of the vessel's outer hull. Of the four vessels, the AMJAD sustained the greatest amount of damage, with the largest-diameter hull breach, measuring approximately 4 metres by 4.9 metres. The damage caused the engine chamber to flood, disabling the vessel.

*Figure 1: Diagram of the AMJAD highlighting the seat of the explosion*

33. It is assessed that the execution of these attacks required a high level of precision, as demonstrated by the placement of the limpet mine on the hull of each vessel, specifically targeting the engine chamber in each case.<sup>11</sup>

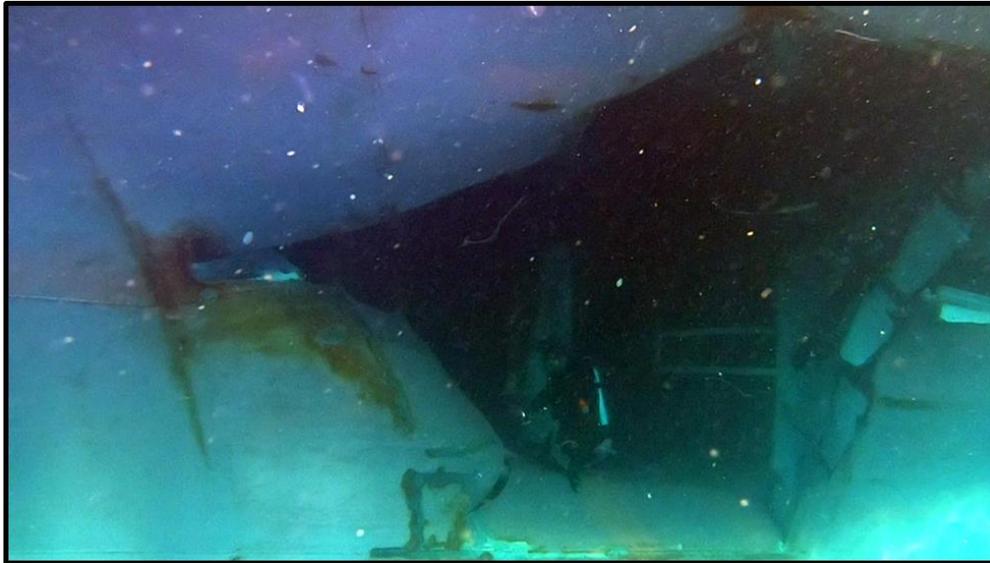
*Figure 2: Image depicting a diver in front of the damaged hull of the AMJAD*

- (b) The damage sustained by each of the four vessels, in particular the extent of the damage and the way in which the damaged parts of the hull bend inwards, into the vessel,<sup>3</sup> indicates a specific, fixed point of detonation originating at the surface of the hull of each vessel.

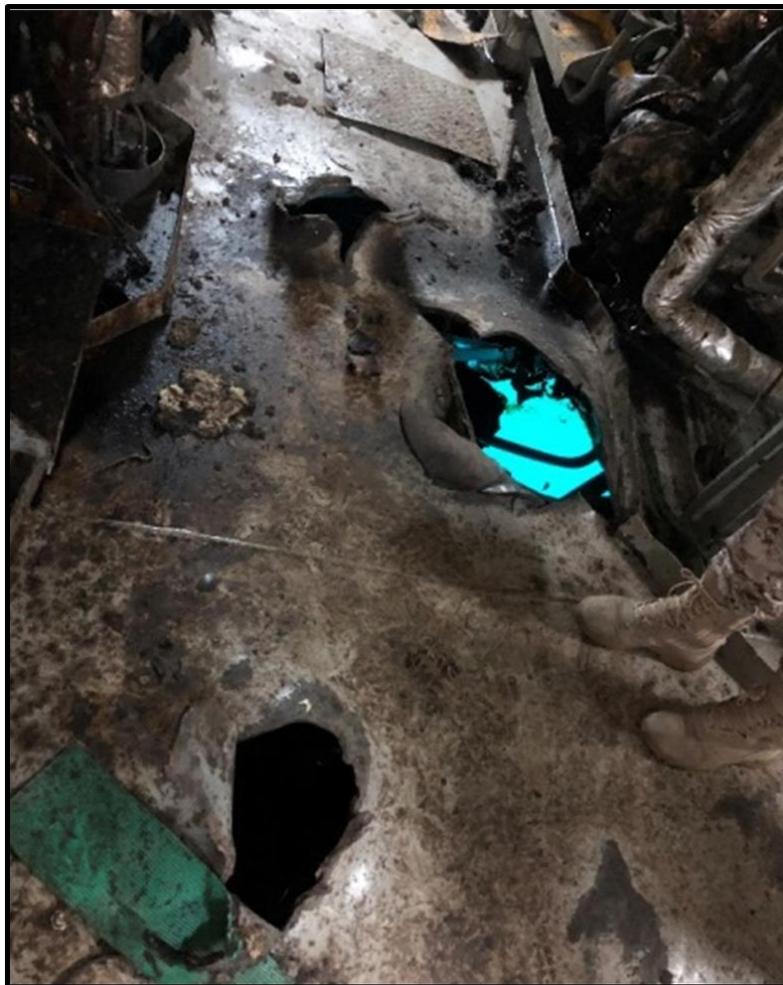
*Figure 3: Damage sustained by the AMJAD under the purifier room, in the engine chamber*

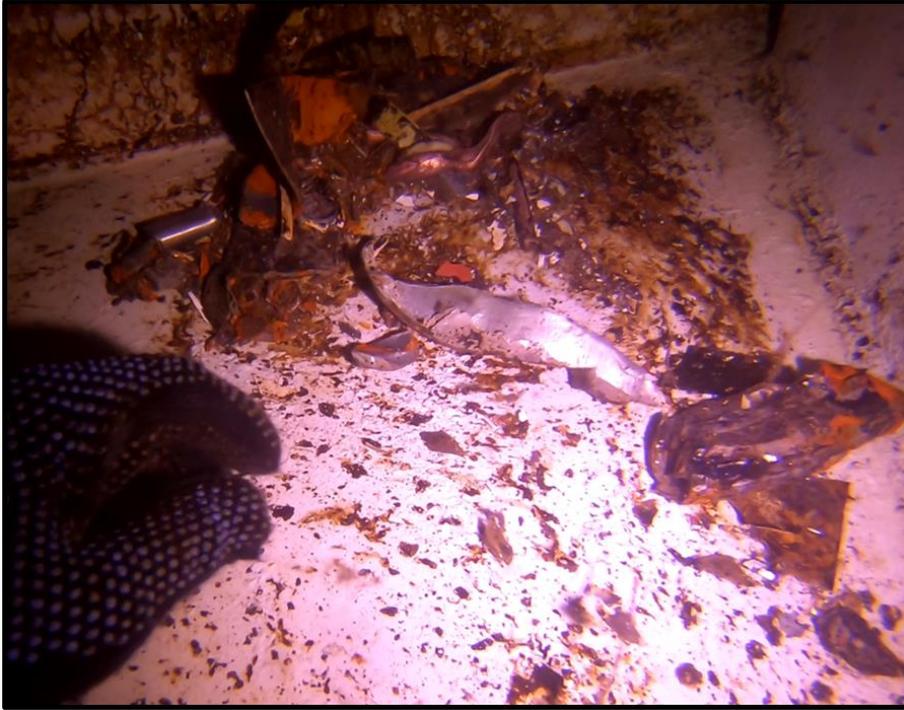
Foreign debris has been recovered from the AMJAD (i.e. remnants of the device used in the attack). XRF elemental analysis of the debris has revealed that it is composed of aluminium.

*Figure 4: Image depicting the recovery of foreign debris from the interior of the AMJAD*

- (c) The foreign debris recovered from all four attack sites is consistent with components of limpet mines. Careful examination and XRF elemental analysis show that the debris recovered from all four attack sites closely resembles, in size, shape, dimensions,<sup>4</sup> and material composition,<sup>5</sup> pieces of a known type of limpet mine.

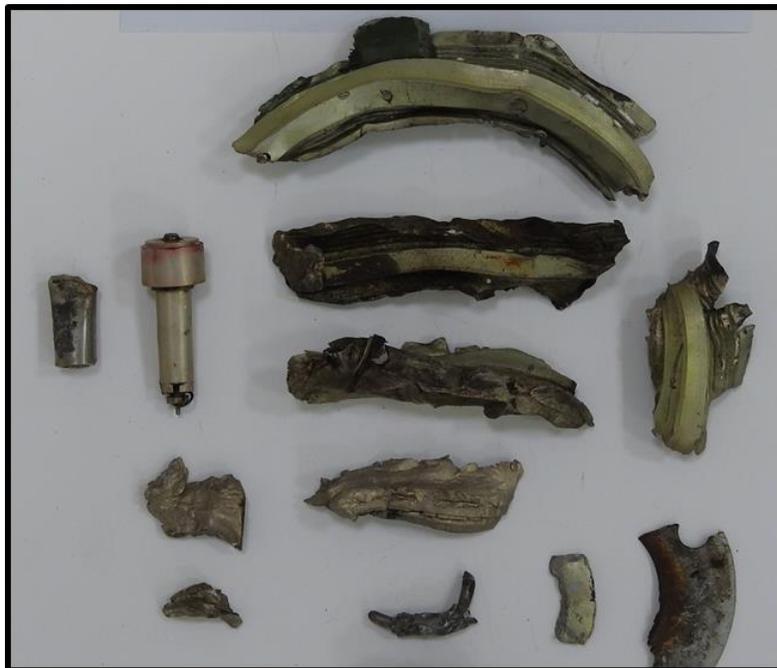
*Figure 5: Foreign debris recovered from the AMJAD*

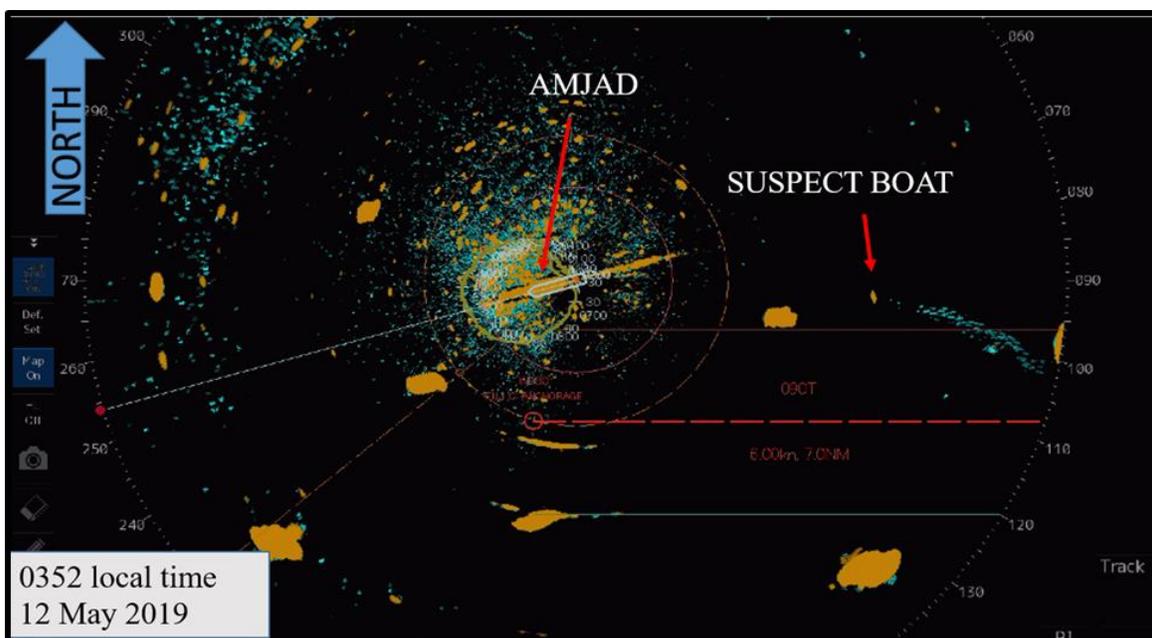
The AMJAD's VDR depicts a suspect fast boat approaching the AMJAD at high speed from the East at 0352 hours local time on 12 May 2019, and staying near the vessel for nine minutes, before departing to the East at 0404 hours at a high speed. The last detection of this suspect fast boat by the AMJAD's VDR is at 0407 hours local time. (For video footage of the AMJAD's VDR, please go to: <https://www.un.int/uae/media/amjad-vdr>.)

**Figure 6:** Image from the AMJAD's VDR depicting the first detection of the suspect fast boat [Note: The large orange shape with a light blue outline at the centre of the image is the AMJAD. The large orange shapes around the AMJAD are other vessels. The small orange specks are 'radar clutter' (waves and water movement picked up as radar noise). The suspect fast boat is identified by a red arrow.]

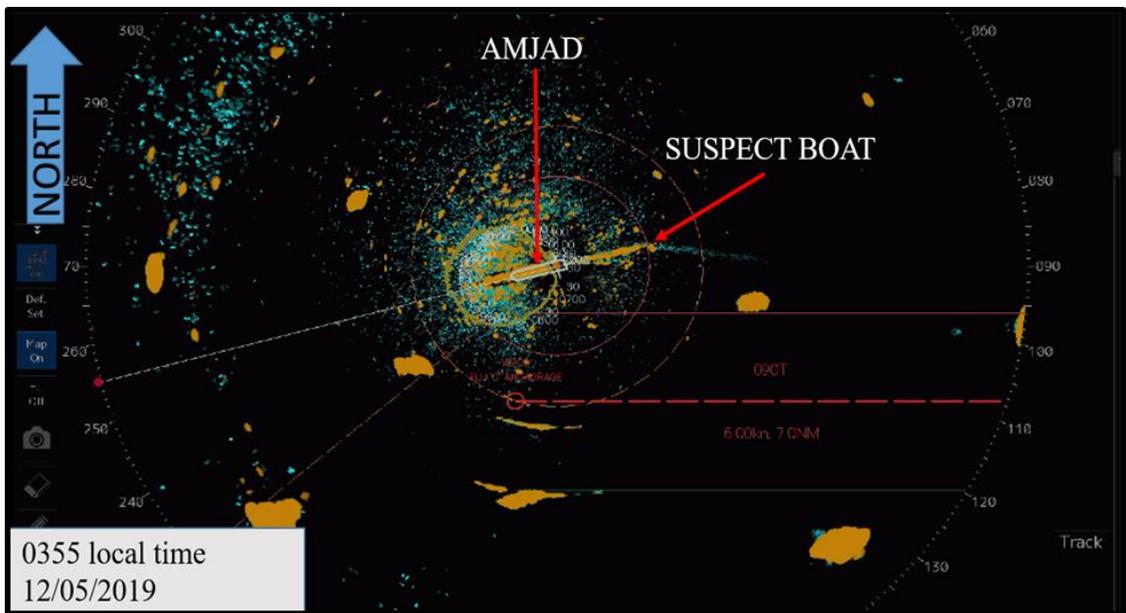
*Figure 7: Image from the AMJAD's VDR depicting the suspect fast boat approaching near the AMJAD*

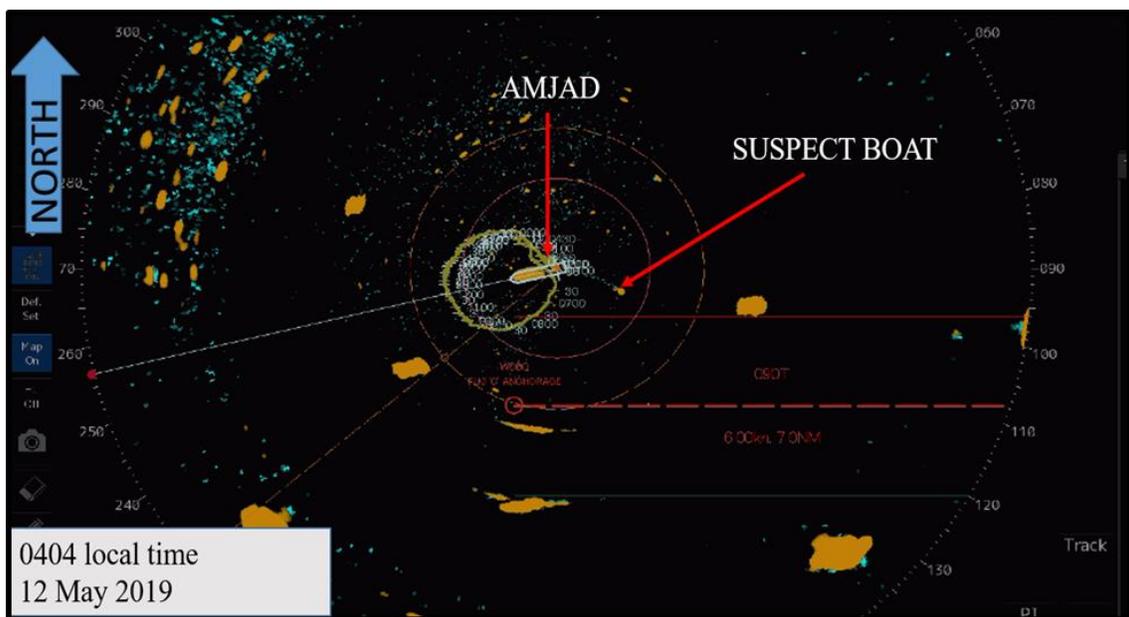
*Figure 8: Image from AMJAD's VDR depicting the suspect boat departing from the AMJAD, nine minutes later*

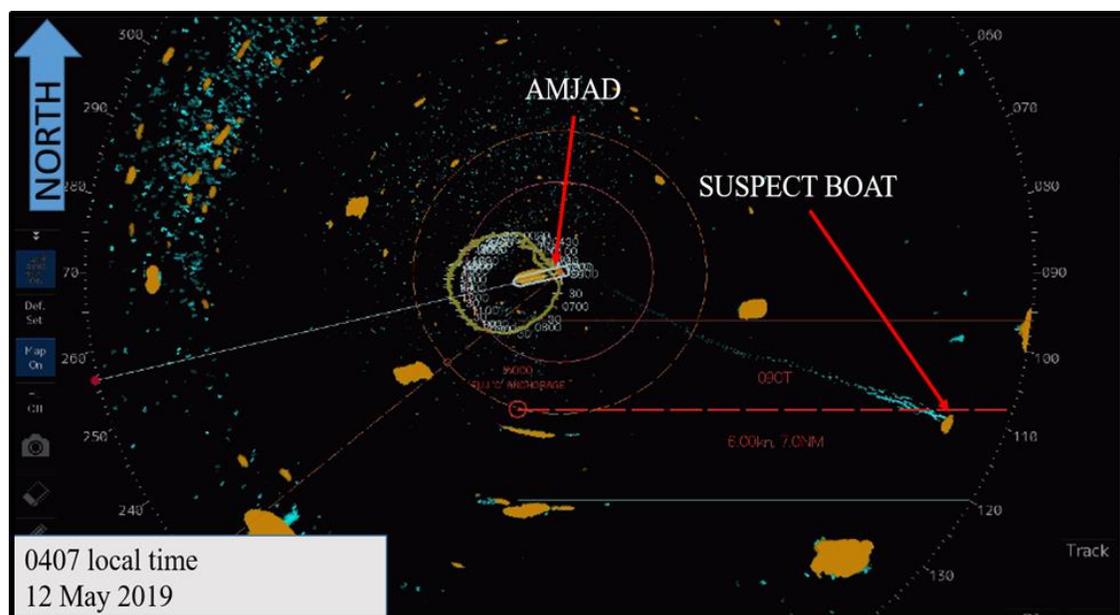
*Figure 9: Image from the AMJAD's VDR, depicting the last detection of the suspect fast boat, departing to the East*

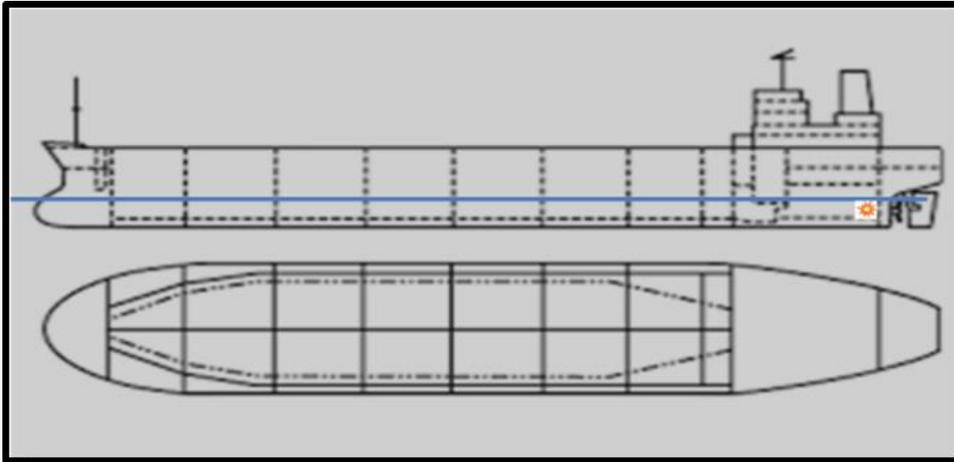
Investigation of the damage sustained by the AL MARZOQAH indicates the seat of the explosion was located on the port side, approximately 1.60 metres below the waterline level, at the engine chamber. As with the other three explosions, this explosion perforated the vessel's outer hull. The AL MARZOQAH sustained a hull breach measuring approximately 3.7 metres by 3.5 metres. The damage caused the engine chamber to flood, disabling the vessel.

*Figure 10: Diagram of the AL MARZOQAH highlighting the seat of the explosion*

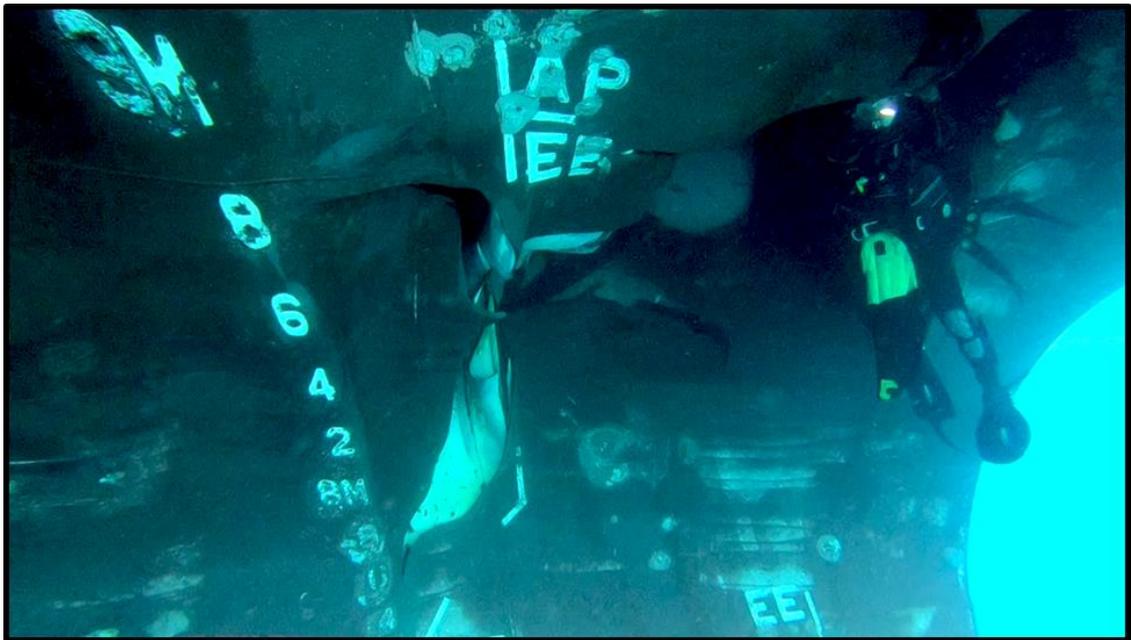
*Figure 11: Image depicting a diver in front of the damaged hull of the AL MARZOQAH*

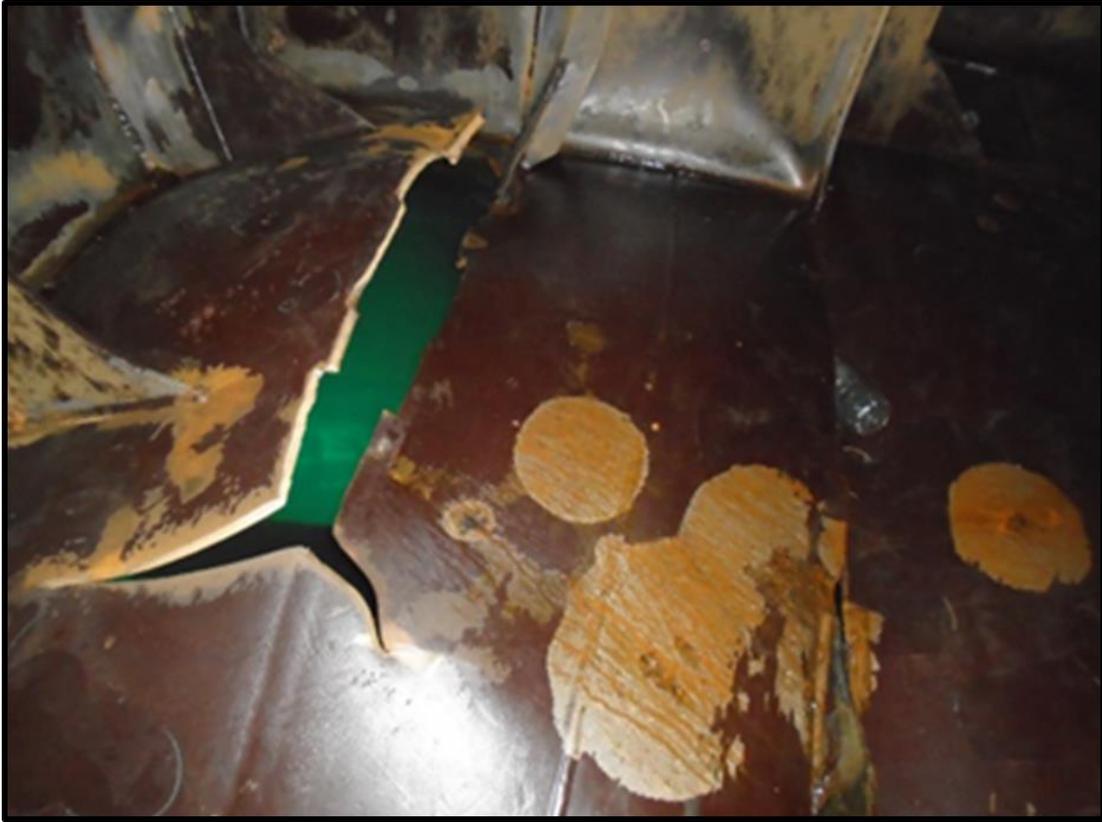
*Figure 12: Damage to the floor of the engine chamber sustained by the AL MARZOQAH*

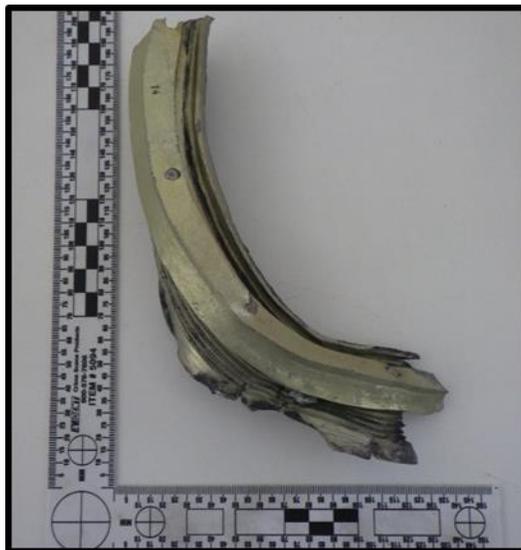
Foreign debris has been recovered from the AL MARZOQAH. XRF elemental analysis of the debris has revealed that it is composed of aluminium.

*Figure 13: Foreign debris recovered from the AL MARZOQAH*

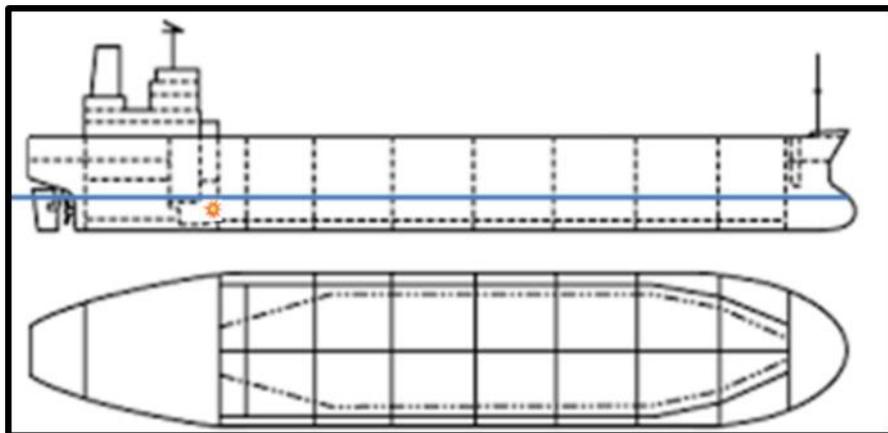
Investigation of the damage sustained by the A.MICHEL indicates that the seat of the explosion was located on the starboard side, approximately 1.1 metres below the waterline level, at the engine chamber. As with the other three explosions, this explosion perforated the vessel's outer hull. The A.MICHEL sustained a hull breach measuring approximately 4 metres by 3 metres. The damage caused the engine chamber to flood, disabling the vessel.

*Figure 14: Diagram of the A.MICHEL highlighting the seat of the explosion*

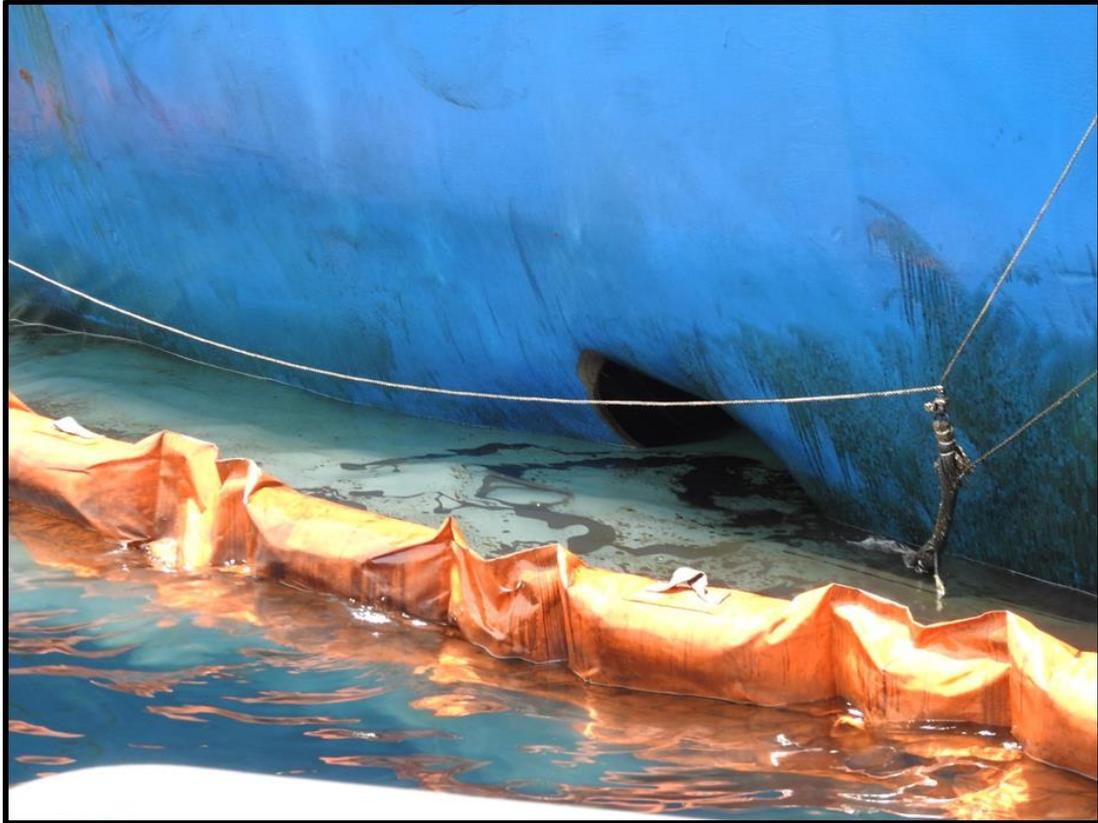
*Figure 15: Exterior of the A.MICHEL, depicting the damage to the hull of the vessel*

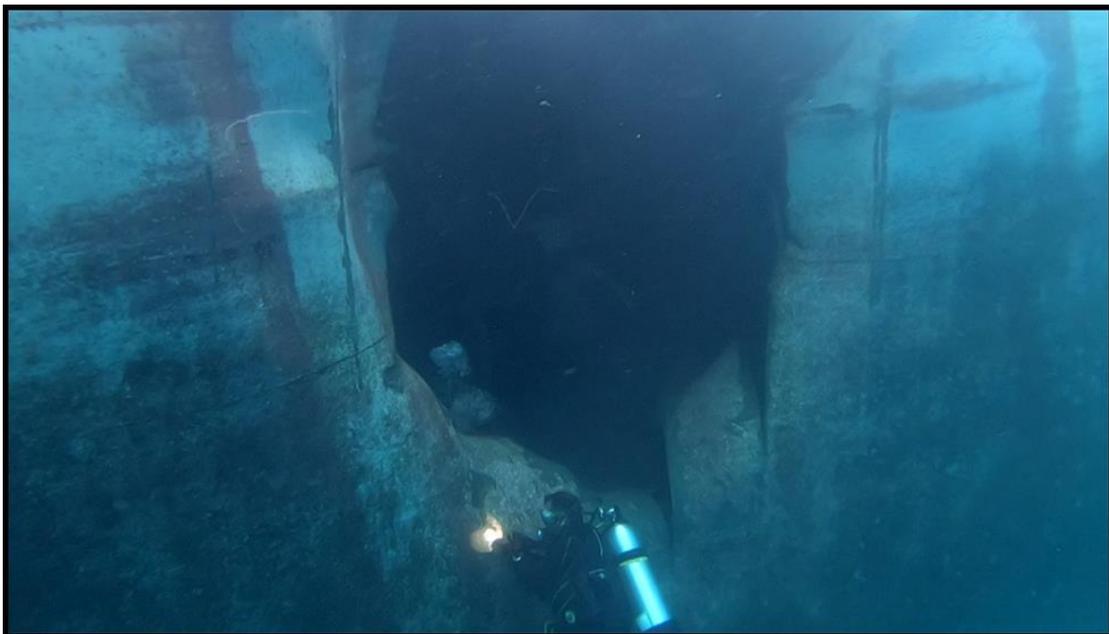
*Figure 16: Image depicting a diver in front of the damaged hull of the A.MICHEL*

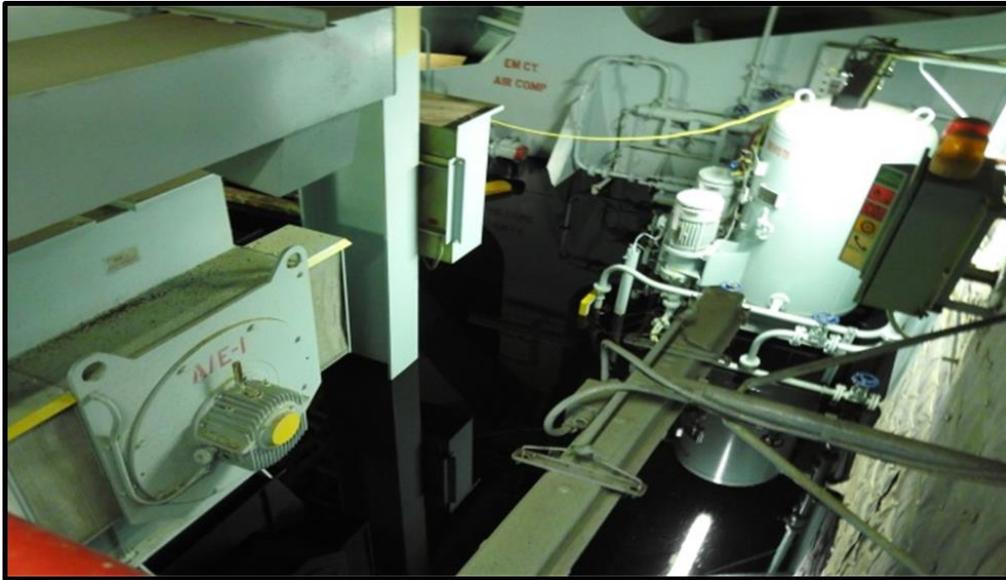
*Figure 17: Flooding to the engine chamber sustained by the A.MICHEL*

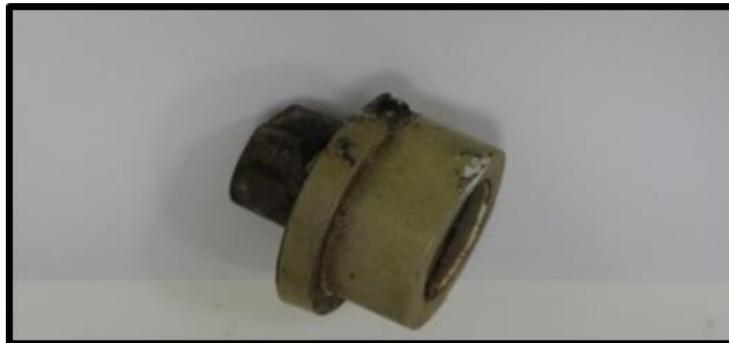
Foreign debris has been recovered from the A.MICHEL. XRF elemental analysis of the debris has revealed that it is composed of aluminium.

*Figure 18: Foreign debris recovered from the A.MICHEL*

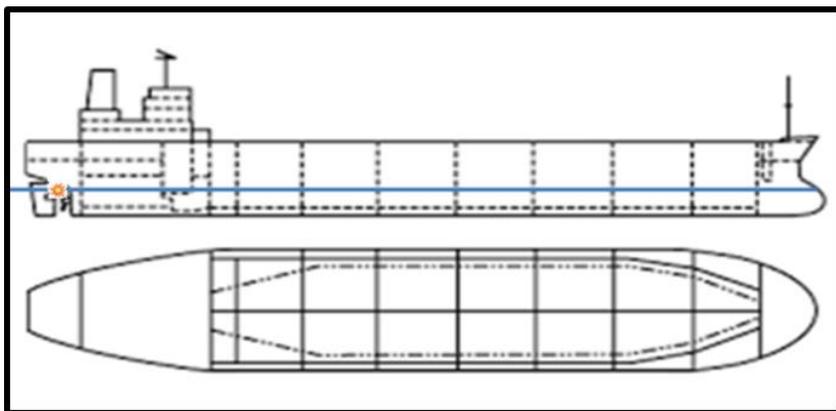
Investigation of the damage sustained by the ANDREA VICTORY indicates that the location of the explosion was on the stern, below or at the waterline level, at the engine chamber. As with the other three explosions, this explosion perforated the vessel's outer hull. The ANDREA VICTORY sustained a hull breach measuring approximately 2.6 metres by 3 metres. As soon as the explosion occurred, the crew of the vessel responded by sealing the area, preventing flooding to the engine chamber. The internal chamber below the engine chamber sustained some flooding.

*Figure 19: Diagram of the ANDREA VICTORY highlighting the seat of the explosion*

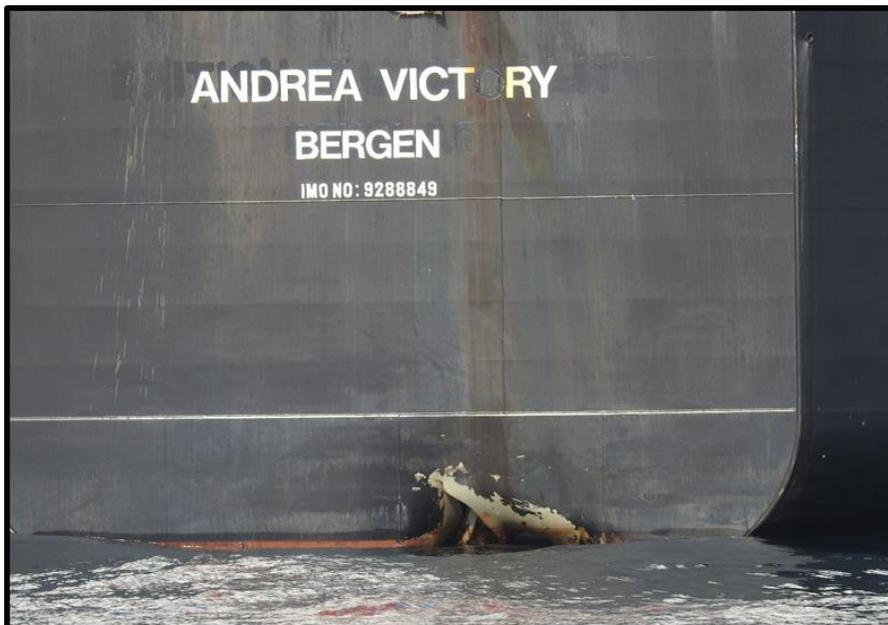
*Figure 20: Exterior of the ANDREA VICTORY, depicting the damage to the hull of the vessel*

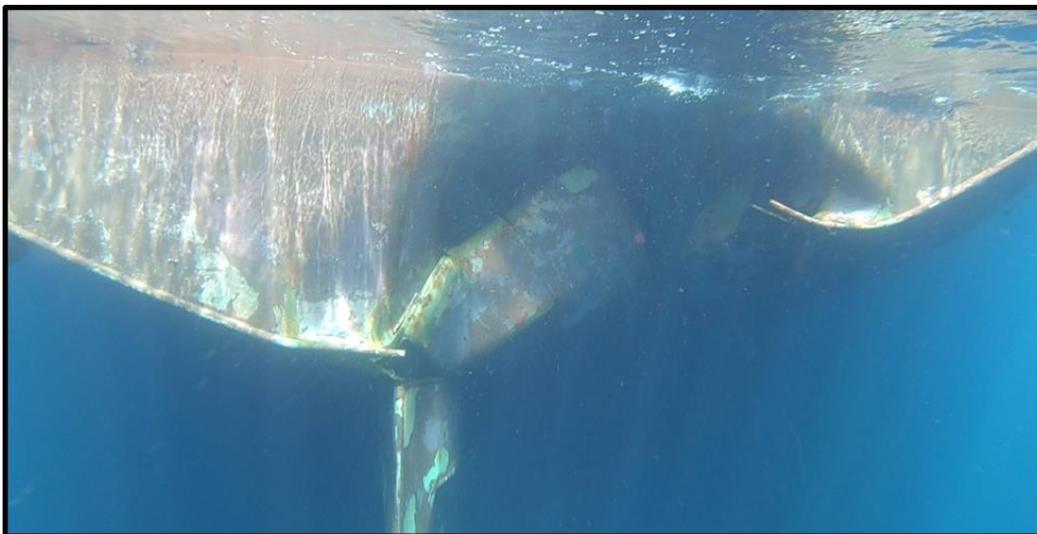
*Figure 21: Hull damage sustained by the ANDREA VICTORY*

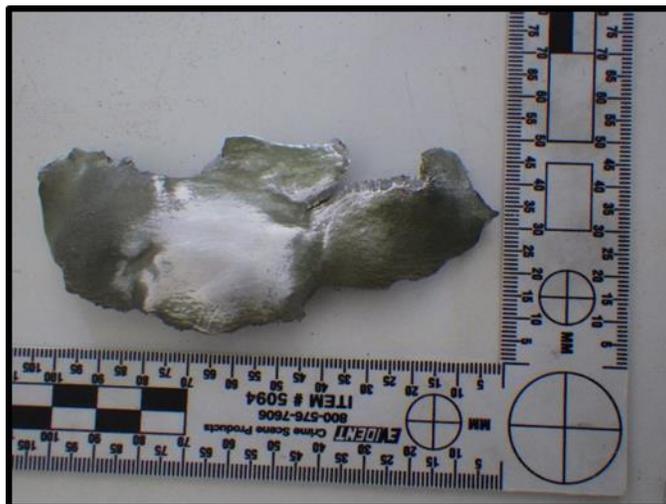
Foreign debris has been recovered from the ANDREA VICTORY. XRF elemental analysis of the debris has revealed that it is composed of aluminium.

*Figure 22: Foreign debris recovered from the ANDREA VICTORY*
